Flood Control Project Maintenance
2011 Structure Summary Report
Overall Unit and Item Ratings

Reclamation District No. 2063 Pumping Plant (Nelson Drain)

Flood Control Project Maintenance**Unit Cover Sheet****2011 Pumping Plant Inspection Results****Reclamation District No. 2063 Crows Landing**

Pumping Plant Rating	U
Date of Inspection	7/28/2011
DWR Inspector	Pavel Kazi
Accompanied By

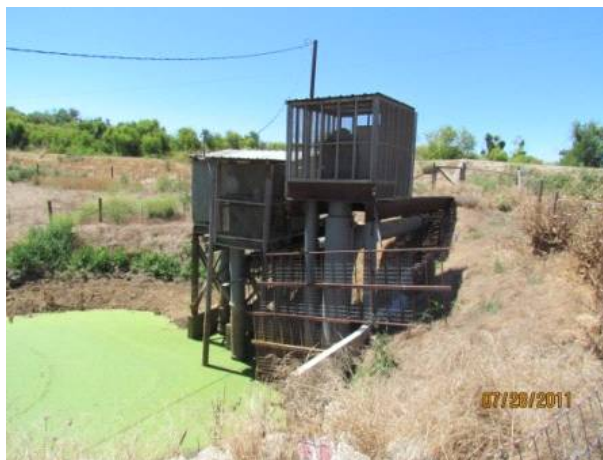
Levee Mile Report Line	4
Start Levee Mile	
End Levee Mile	
Location	
Category	Pump Stations
Item	Plant Building

LMR No.	Levee Mile		Category	Item	Location *	Rating **	Action/Comment	GPS Latitude/Longitude		Issue No.
	Start	End						Start	End	Photo
1			Pump Stations	Operating Log		N	Item inspected visually only. Item was not operated during the inspection. Inspector Comments: The plant building was not accessible to inspect operating log.	°	°	1
2			Pump Stations	Operation & Maintenance Manual		N	Item inspected visually only. Item was not operated during the inspection. Inspector Comments: The plant building was not accessible to inspect O&M manual.	°	°	2
3			Structures	Photo Documentation			Inspector Comments: Due to lack of response from the maintaining agency this inspection was not able to be completed during the summer 2011 season.	°	°	3
4			Pump Stations	Plant Building		A	Item inspected visually only. Item was not operated during the inspection. Inspector Comments: The plant building appeared to be in good structural condition.	°	°	4 Y

View of the pumping plant.

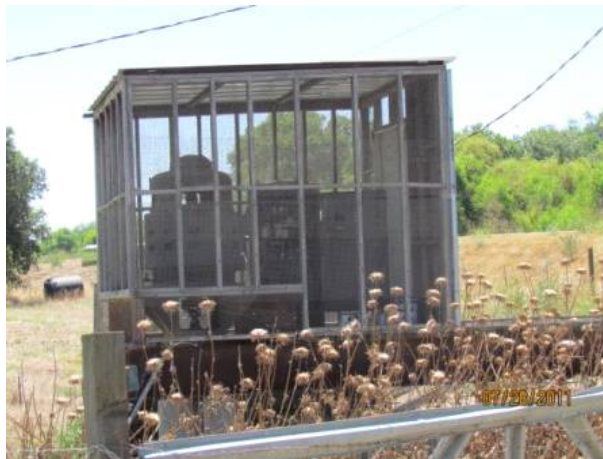
Levee Mile Report Line	7
Start Levee Mile	
End Levee Mile	
Location	
Category	Pump Stations
Item	Pumps

View of the pumps at the plant.

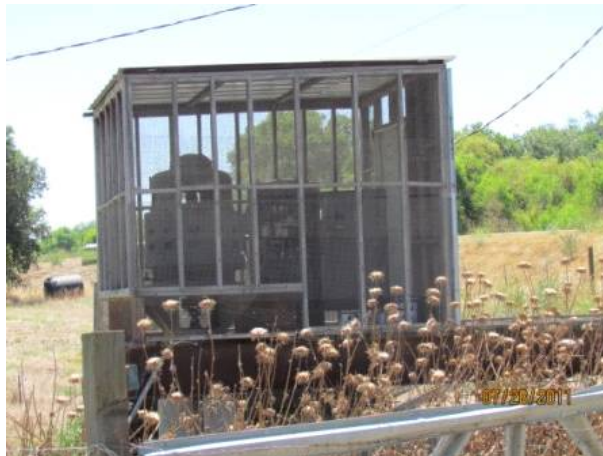
Levee Mile Report Line	8
Start Levee Mile	
End Levee Mile	
Location	
Category	Pump Stations
Item	Motors, Engines, Fans & Gear Reducers

View of the pump at the pumping plant.

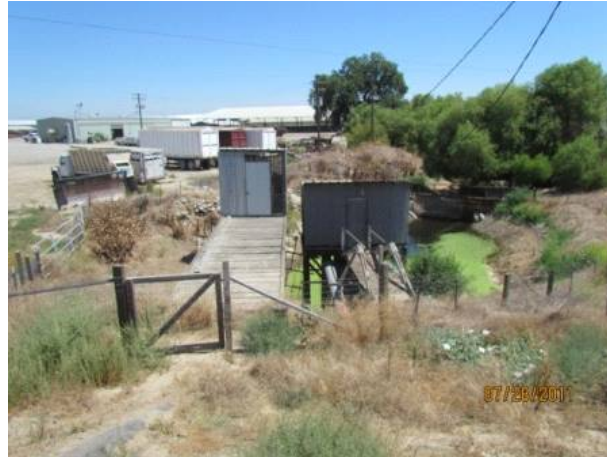
Levee Mile Report Line	9
Start Levee Mile	
End Levee Mile	
Location	
Category	Pump Stations
Item	Power

View of the power sources for the pumping plant.

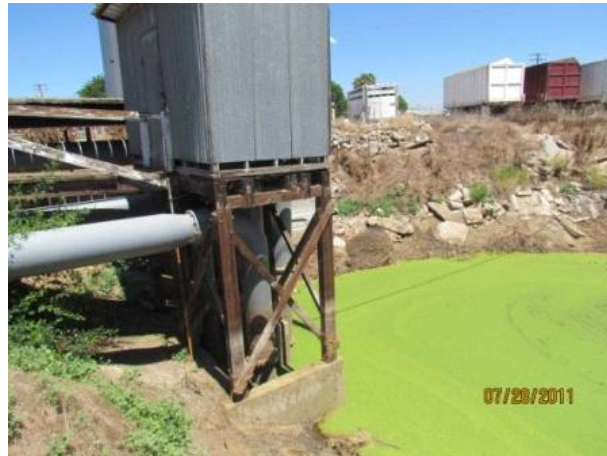
Levee Mile Report Line	12
Start Levee Mile	
End Levee Mile	
Location	
Category	Pump Stations
Item	Sumps/Wet Well

LIR No.	Levee Mile		Category	Item	Location *	Rating **	Action/Comment	GPS Latitude/Longitude		Issue No.
	Start	End						Start	End	Photo
12			Pump Stations	Sumps/Wet Well		M	Item inspected visually only. Item was not operated during the inspection. Inspector Comments: The sump well had debris and sediments which could obstruct the flow of the pumping operation.	°	°	12 Y
13			Pump Stations	Trash Racks		A	Item inspected visually only. Item was not operated during the inspection. Inspector Comments: The trash racks appear to be fastened in place but collected debris might obstruct the flow through the gate.	°	°	13 Y
14			Pump Stations	Trash Rakes		N	Item inspected visually only. Item was not operated during the inspection. Inspector Comments: Trash rakes were not present at this plant.	°	°	14
15			Pump Stations	Electric Gate Operators		N	Inspector Comments: This item doesn't exist at this plant.	°	°	15

View of the wet well.

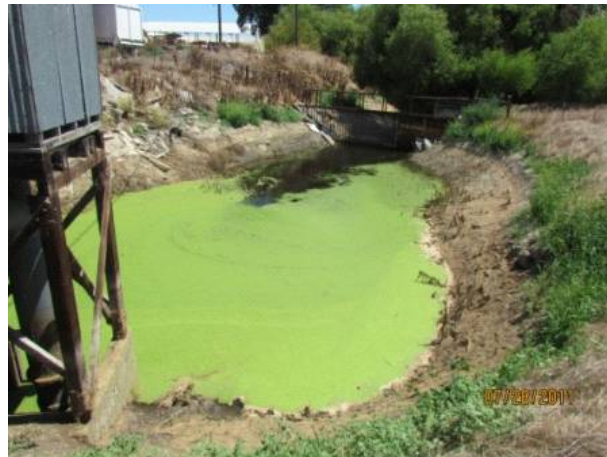
Levee Mile Report Line	13
Start Levee Mile	
End Levee Mile	
Location	
Category	Pump Stations
Item	Trash Racks

View of the trash rack.

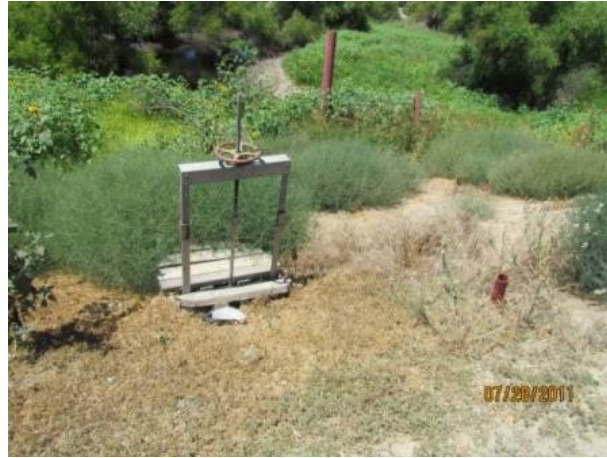
Levee Mile Report Line	17
Start Levee Mile	
End Levee Mile	
Location	
Category	Pump Stations
Item	Manual Gate Operators

16			Pump Stations	Flap Gates		N	Inspector Comments: Flap gate was not visible during inspection.	°	°	16
17			Pump Stations	Manual Gate Operators		A	Item inspected visually only. Item was not operated during the inspection. Inspector Comments: Manual gate operator appears to be in working condition.	°	°	17 Y
18			Pump Stations	Security Fencing		A	Item inspected visually only. Item was not operated during the inspection. Inspector Comments: Security fencing was in good condition and appeared to provide protection against unauthorized access.	°	°	19 Y
19			Pump Stations	Intake and Discharge Pipes		A	Item inspected visually only. Item was not operated during the inspection. Inspector Comments: The intake and discharge pipes appeared to be in good condition.	°	°	20 Y
20			Pump Stations	Pressurized Pipe		A	Item inspected visually only. Item was not operated during the inspection. Inspector Comments: The pipe appeared to be in good condition.	°	°	21 Y

View of the manual gate operator.

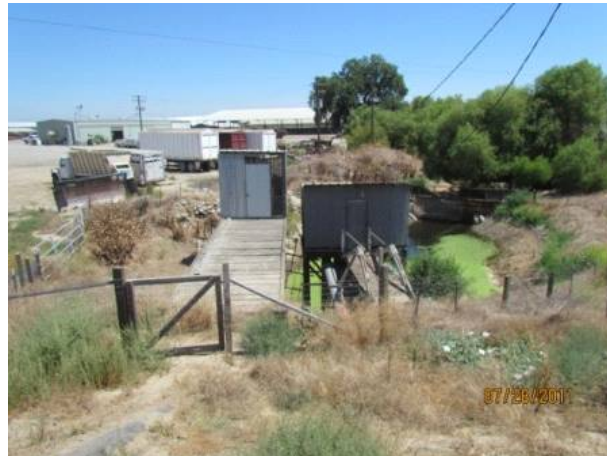
Levee Mile Report Line	18
Start Levee Mile	
End Levee Mile	
Location	
Category	Pump Stations
Item	Security Fencing

View of the security fencing.

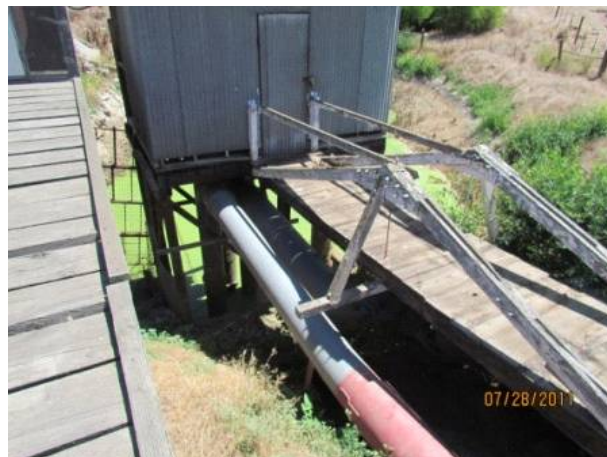
Levee Mile Report Line	19
Start Levee Mile	
End Levee Mile	
Location	
Category	Pump Stations
Item	Intake and Discharge Pipes

View of the pipes at the plant.

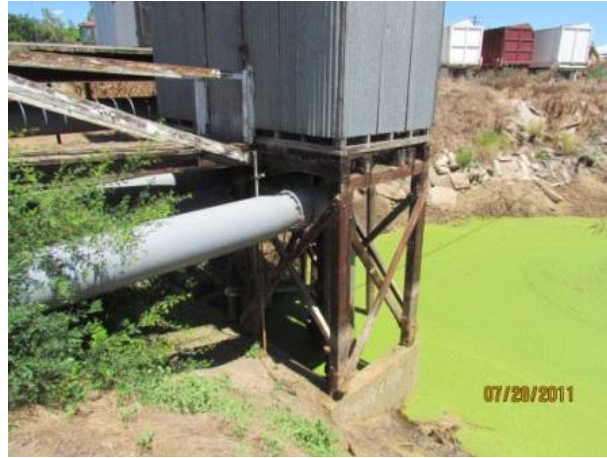
Levee Mile Report Line	20
Start Levee Mile	
End Levee Mile	
Location	
Category	Pump Stations
Item	Pressurized Pipe
View of the pipe.	
pkazi_t_20110825_109.jpg
